# Odra Steam Tug

## *Nadbór*

Report on condition, restoration and possibility of  
operating the engine for display purposes.

Survey undertaken September 2000

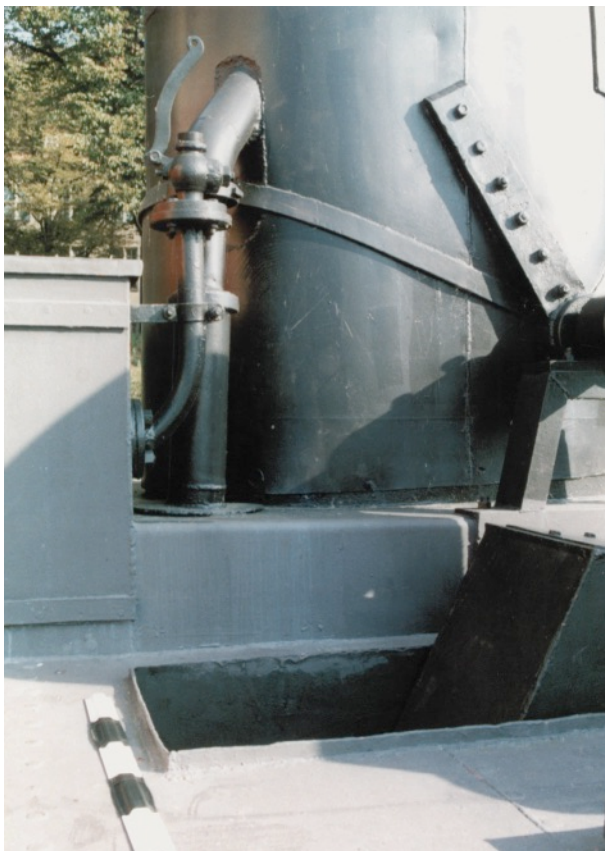
*The base of the funnel showing the whistle fitting and the recess for the counter-balance weights. The drains for the recess should be kept clear to allow water to run off and not cause corrosion.*

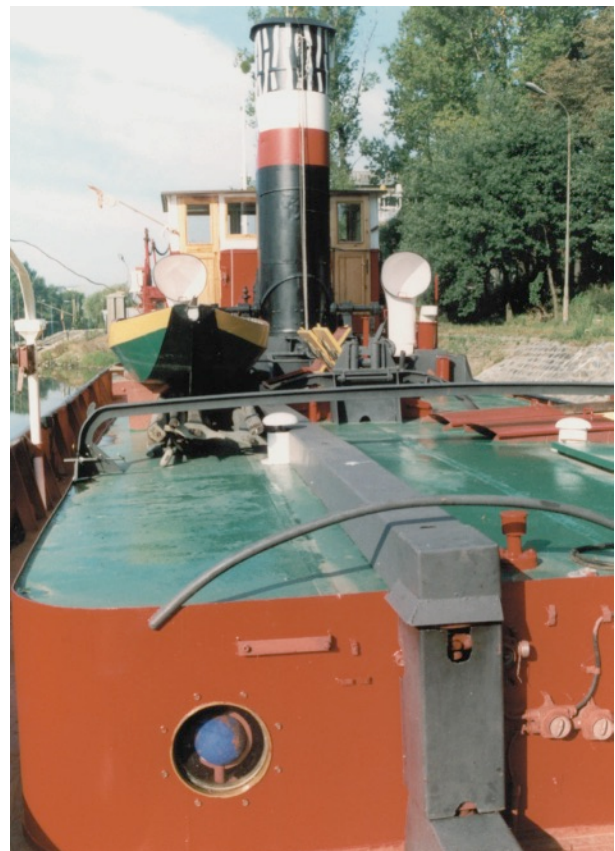
The towing equipment needs some work to ensure that everything is free and in working condition. The guide over the rear deck has been removed for safety reasons. The steering gear is not in good order and needs to be stripped down and rebuilt to ensure that it does not corrode and that it operates easily.

*The steering drive which needs checking and cleaning so that the gears and shafts operate smoothly.*

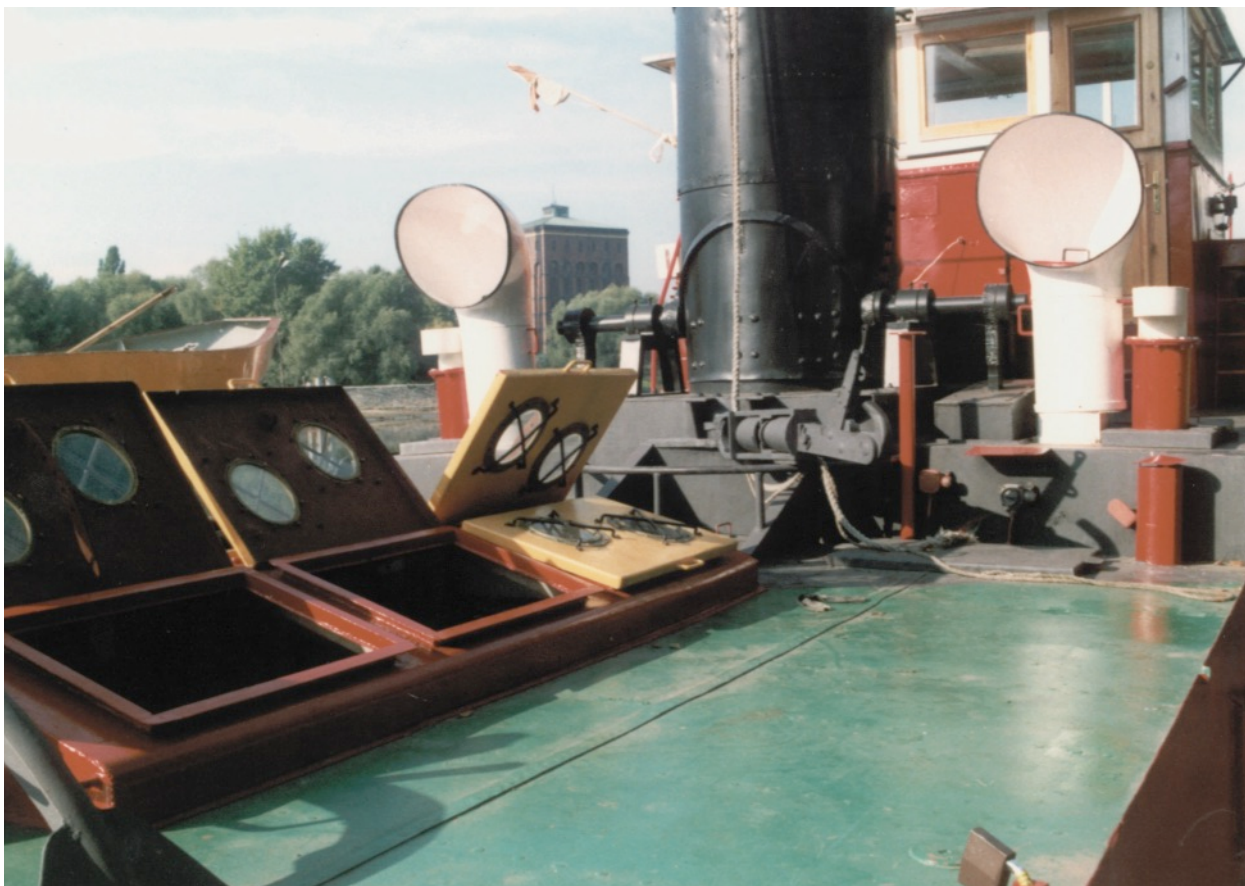
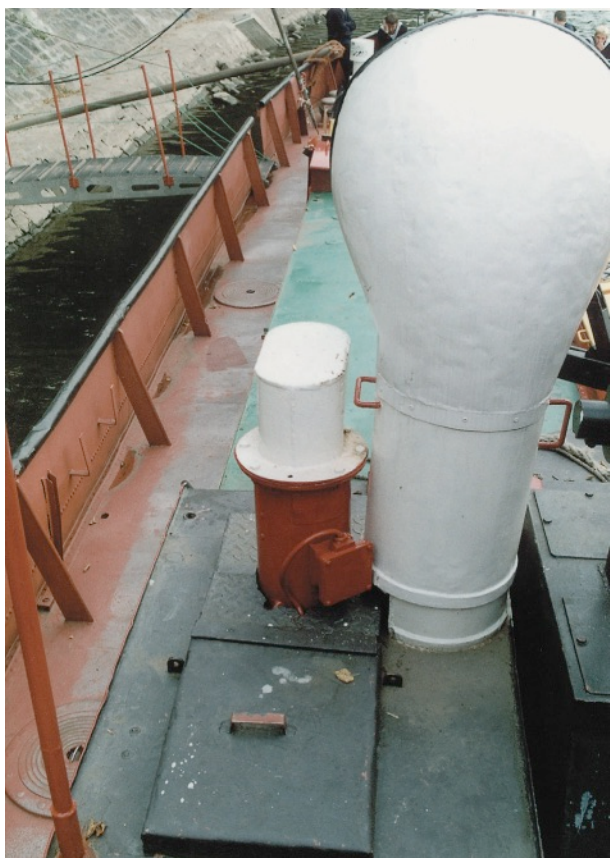
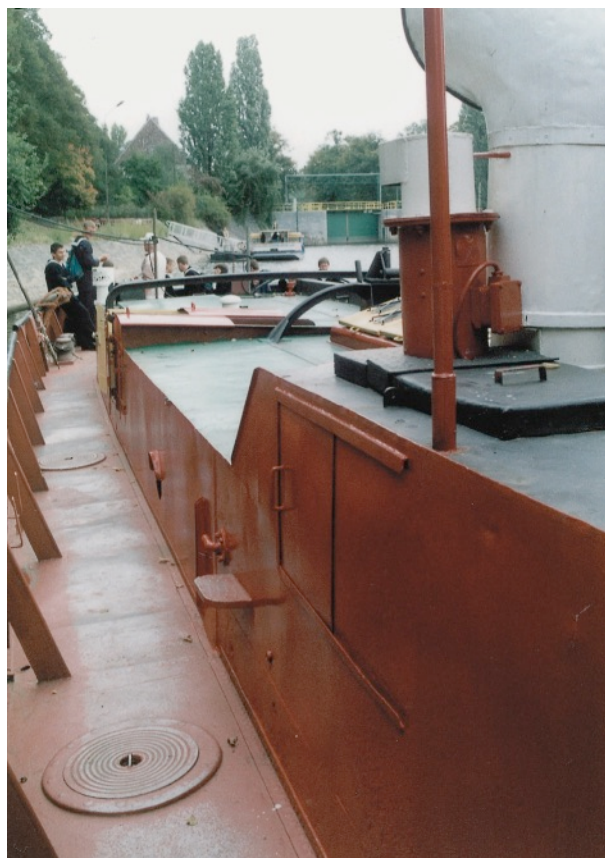
*All the various openings, access points and ventilators shown in these photos need checking and freeing where necessary. It is important to keep rain and snow out of the engine and boiler room as well as the other cabins.*

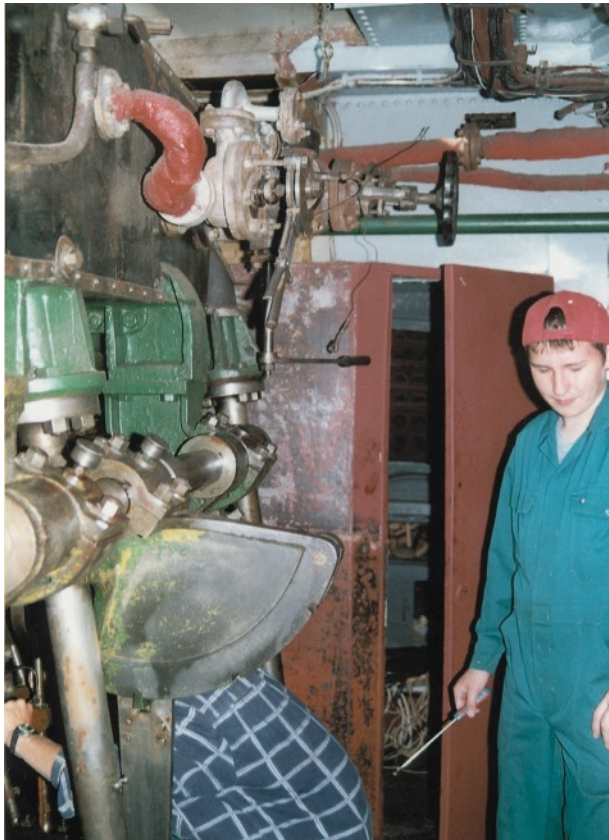
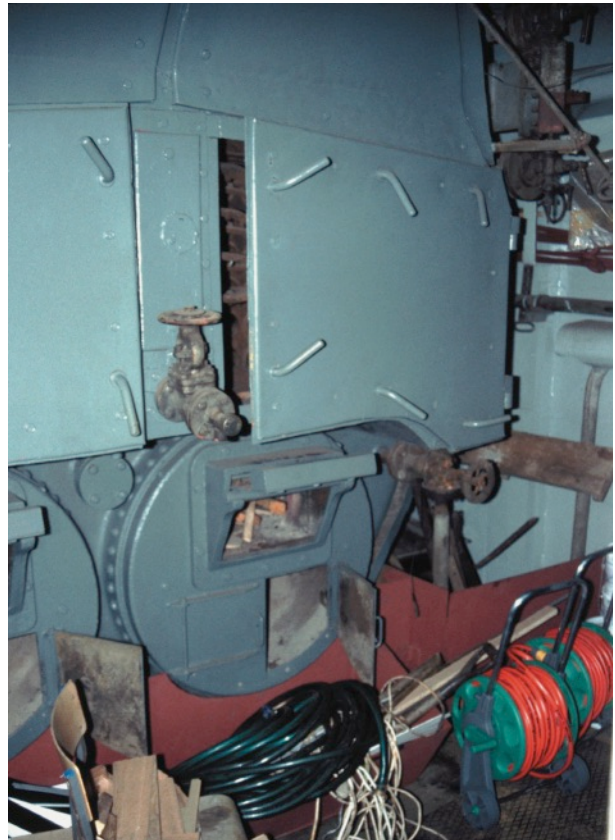
Grit from blasting has covered most of the machinery. It should be carefully removed, particularly from bearing surfaces and from around bearings. By regular cleaning over a long period, most of the grit should be removed.

*Two general views of the engine room and boiler room.*

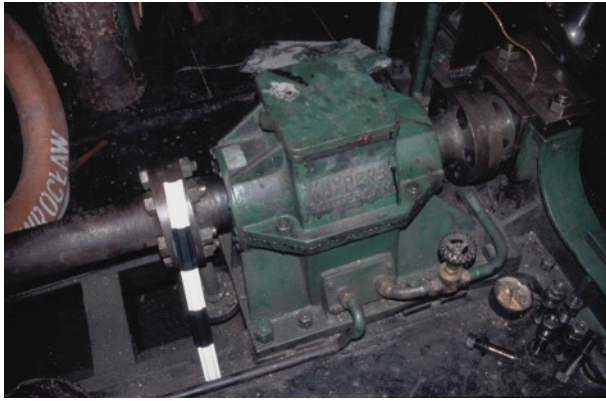
The thrust bearing was partially dismantled and the propellor shaft disconnected from the engine. This was to ensure that the main stern gland as it could do if the shaft was turned. The stern gland was greased afterwards, and a the gland should be greased every few months to ensure that it remains water-tight and in good condition. The thrust bearing itself was full of grit as the fixing studs for the cover had been removed, leaving the top of the bearing somewhat unprotected from dirt. A considerable amount of grit was removed and the thrust plates cleaned, but the oil reservoir was not touched and it will definitely contain much grit and dirt. This needs to be removed before the engine is turned over regularly.

*The thrust block and the coupling which was disconnected.*

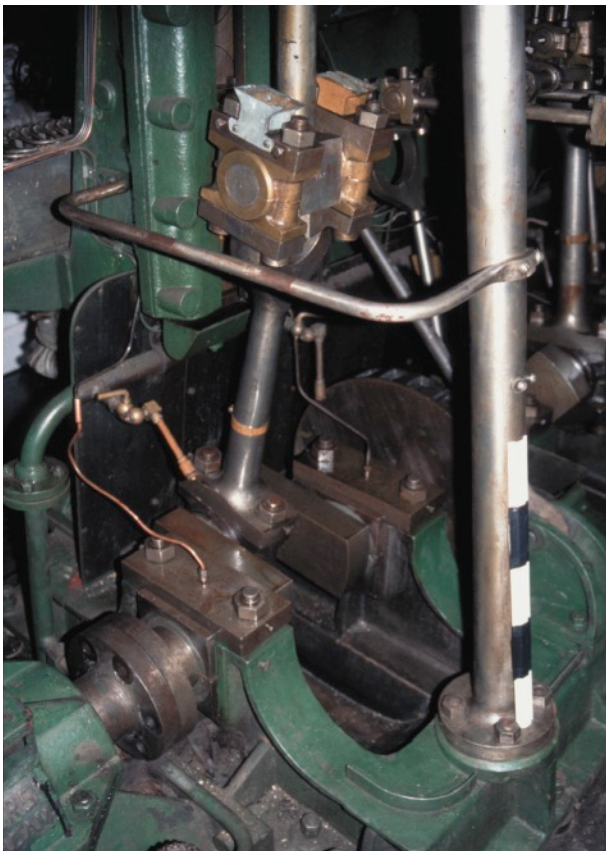
*The bearings which were dismantled and the disconnected propeller shaft coupling.*

cross-head bearing. There was some wear on both the journals and the bearings, the former also having slight rusting. However, their condition appeared suitable for operating the engine for demonstration purposes.

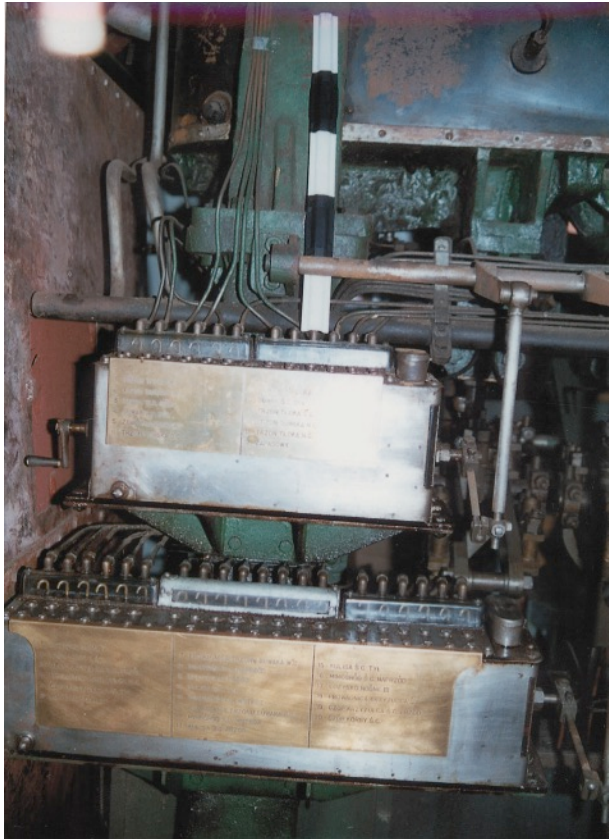
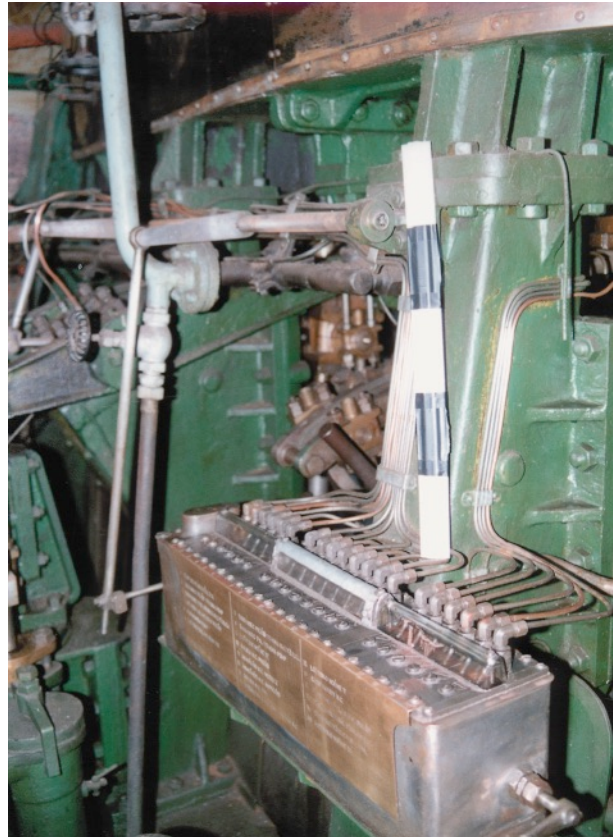
There are three lubricators, two for the lower bearing surfaces and the third supplying steam oil to the pistons and slide valves. Some of the pipework has been damaged and needs replacing. Other pipes may be blocked. The whole system needs checking to ensure that the engine is well lubricated.

*Above: The high and intermediate lubricators on the left and the low pressure on the right.  
Below: The high and intermediate cylinder reversing gear.*

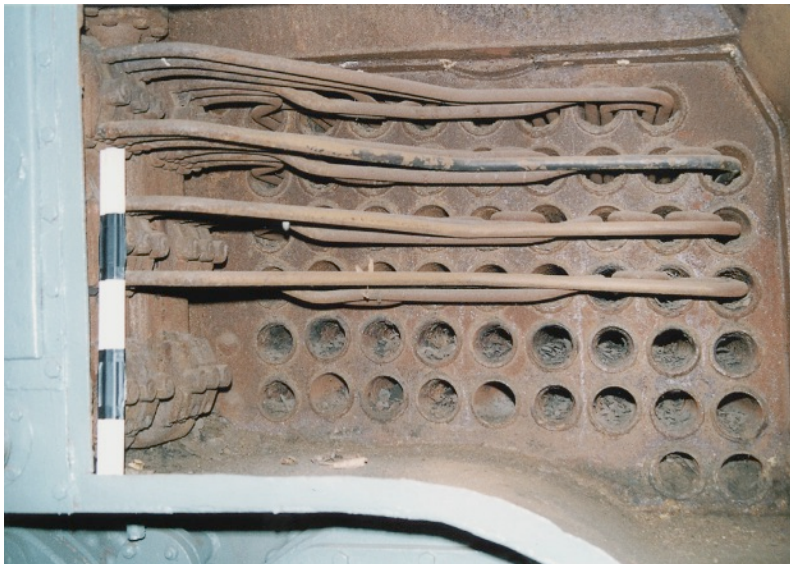
The tubes are in very poor condition and have been welded to the tube plate which suggests that this boiler is quite old. The tube plate itself is severely pitted. One of the super-heater tubes is holed. Much corrosion will have been caused by rain and snow coming down the funnel. This needs to be covered, perhaps at the point where it folds down.

*Left: The superheater tubes, tube plate and tubes.*

If the engine is only going to be turned over for demonstration, the original boiler could be retained just as an exhibit. The boilers used on these tugs are well documented, extensive drawings being available. The boiler could be cut just behind the dome such that the firebox and boiler front is retained. The operation of the original boiler could then be described for visitors. The remaining section of the boiler room, comprising around 4 metres in length, could be used for the installation of a small package boiler or compressor which could be used for turning the engine. This would probably leave enough space to create a small storage area.
